# WROUGHT IRON *for* UNDERGROUND SERVICES

A TECHNICAL BULLETIN PREPARED BY THE ENGINEERING SERVICE DEPARTMENT

**A. M. BYERS COMPANY • PITTSBURGH, PA.**

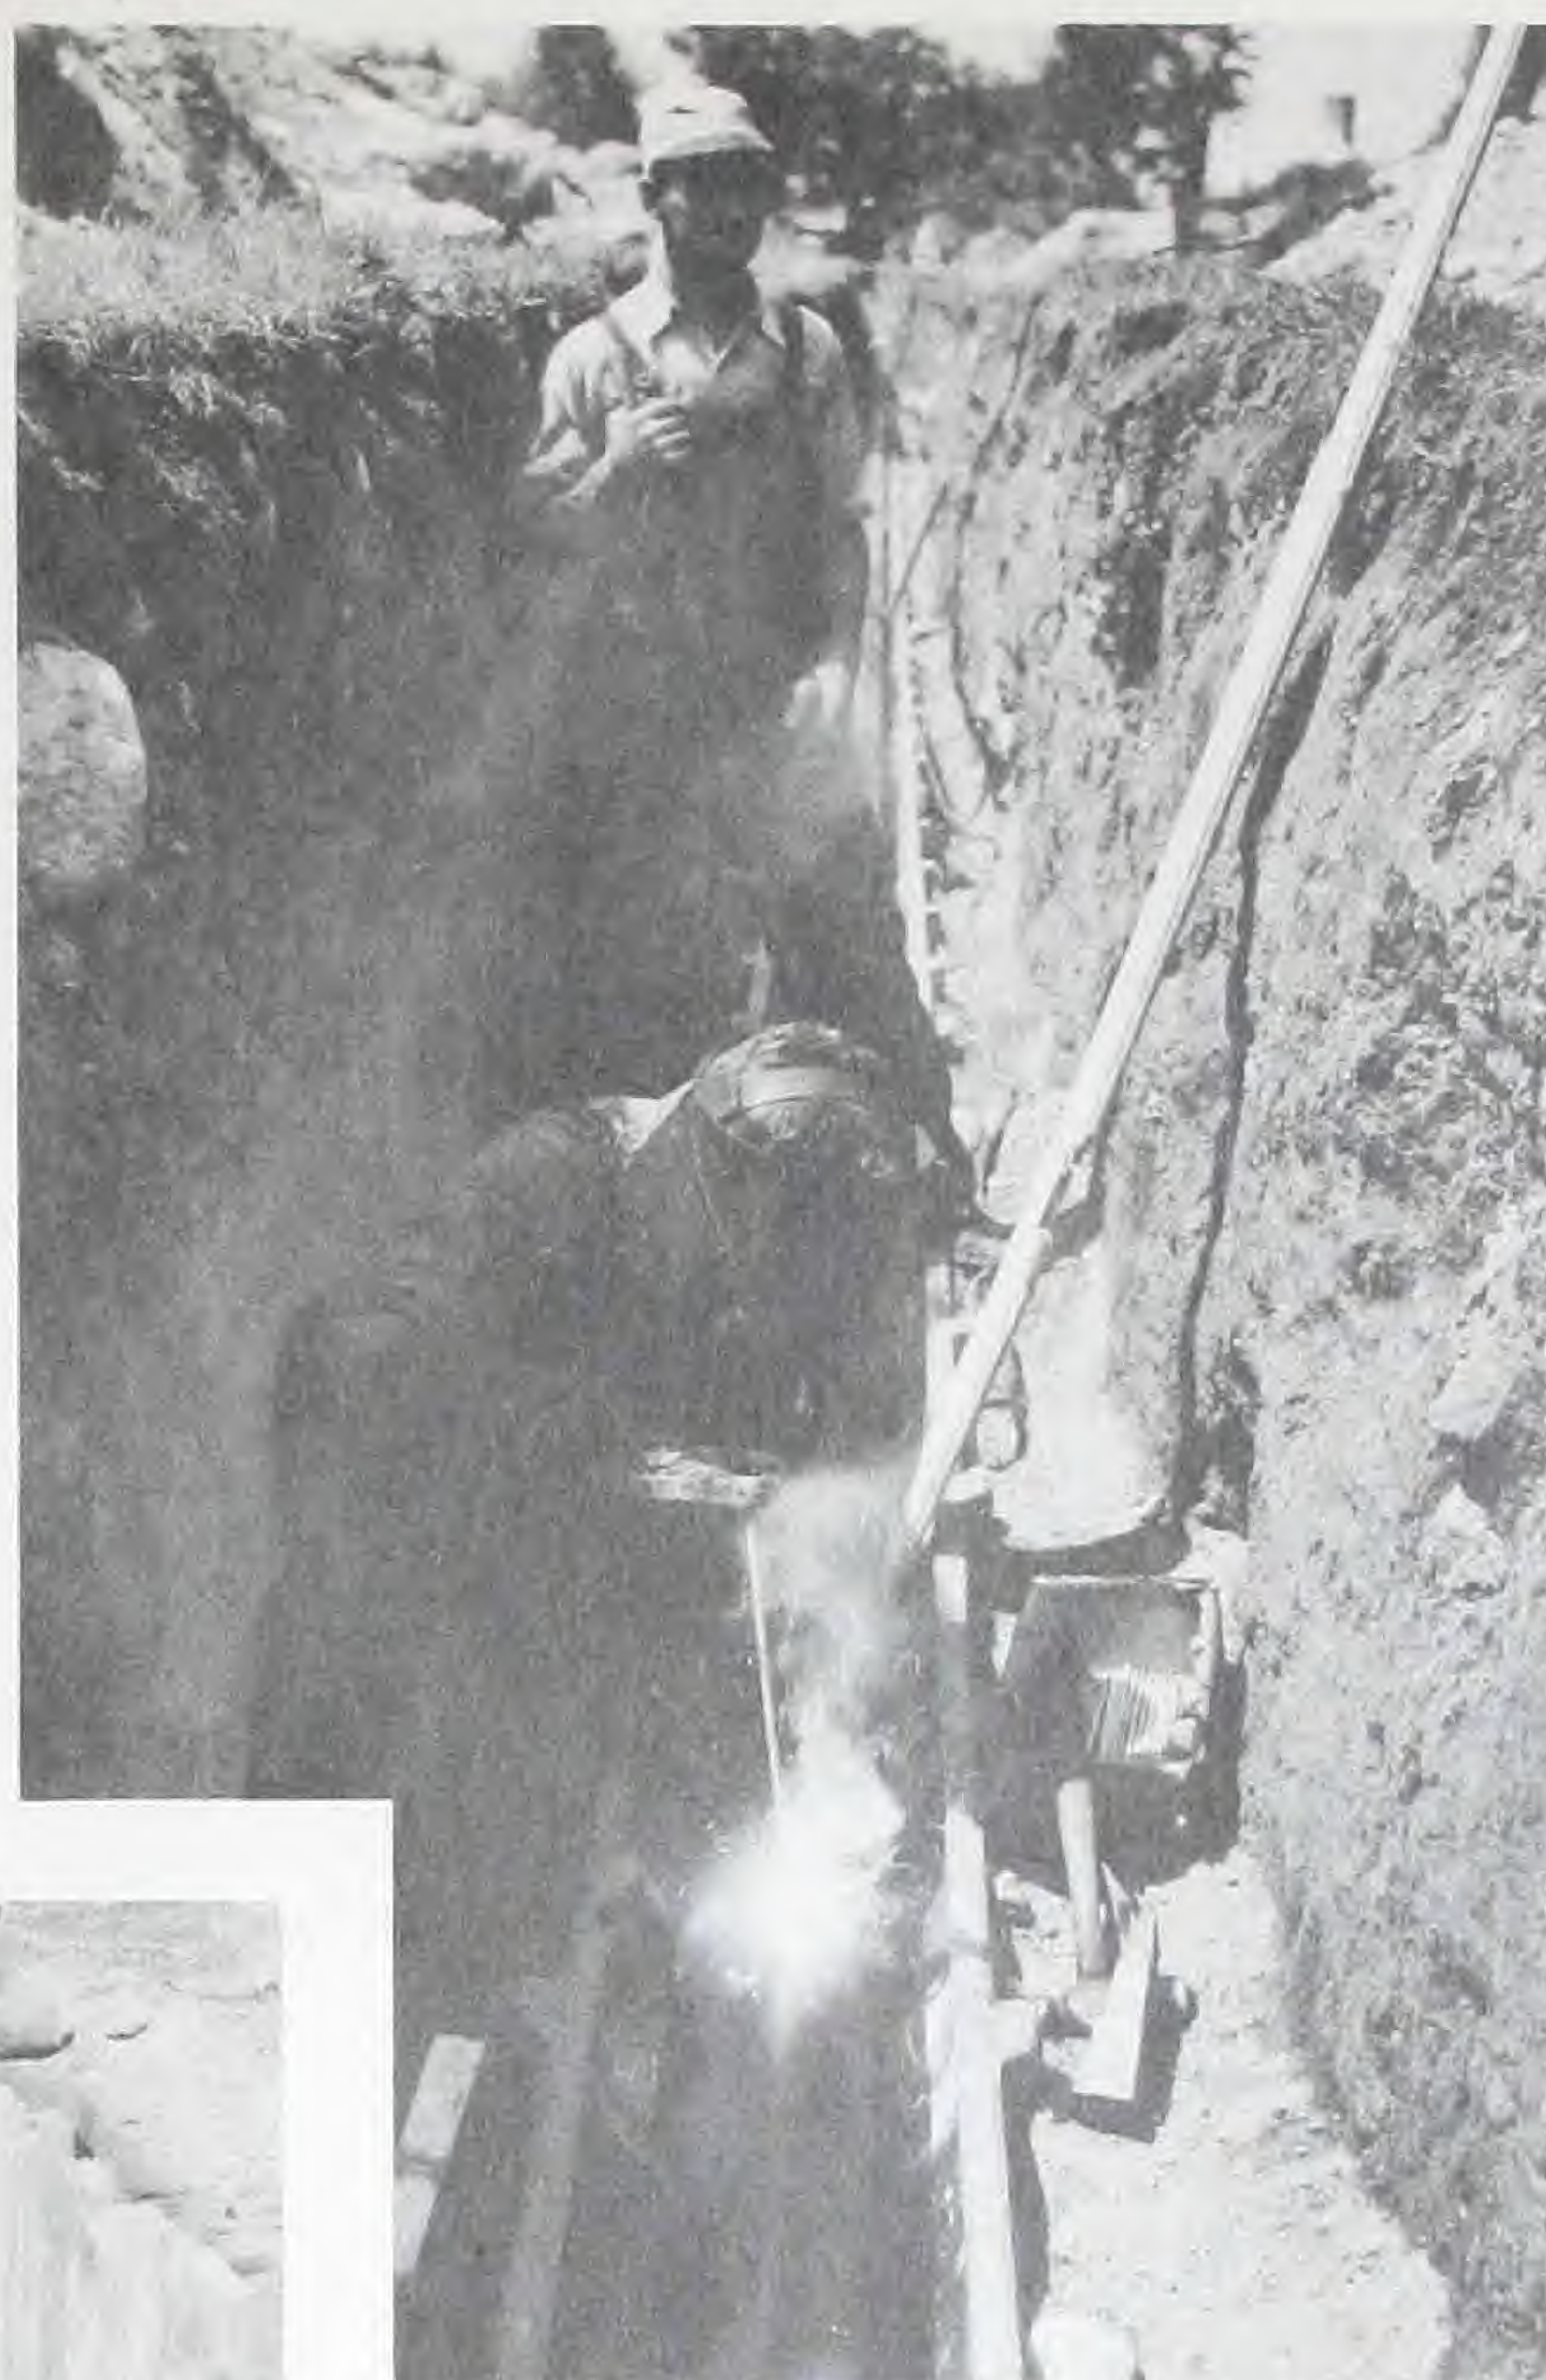
Fig. 46

Welding was the method selected for joining the lengths of wrought iron pipe shown in Fig. 46. This photograph was taken at Phillips Academy, Andover, Massachusetts, and shows part of the underground steam heating system being installed.

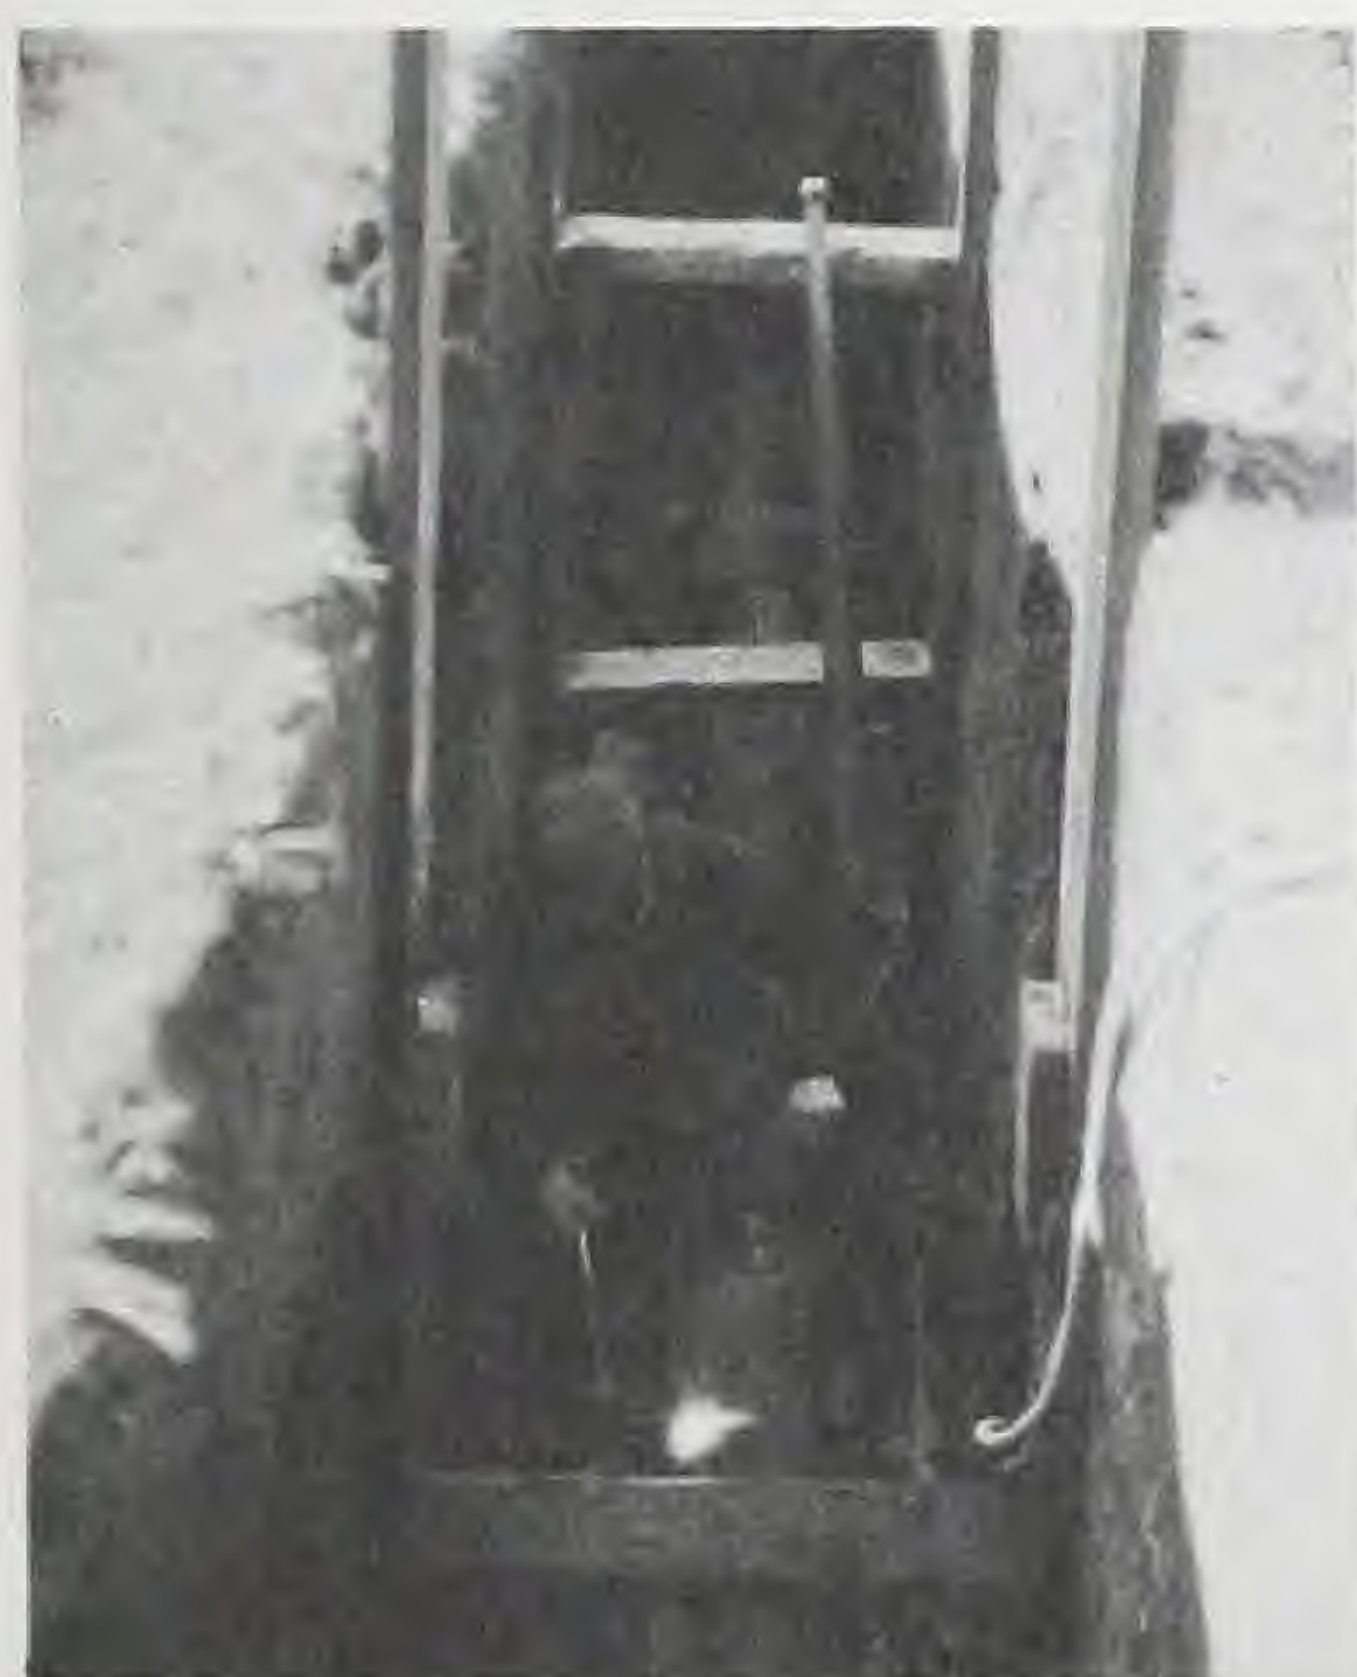
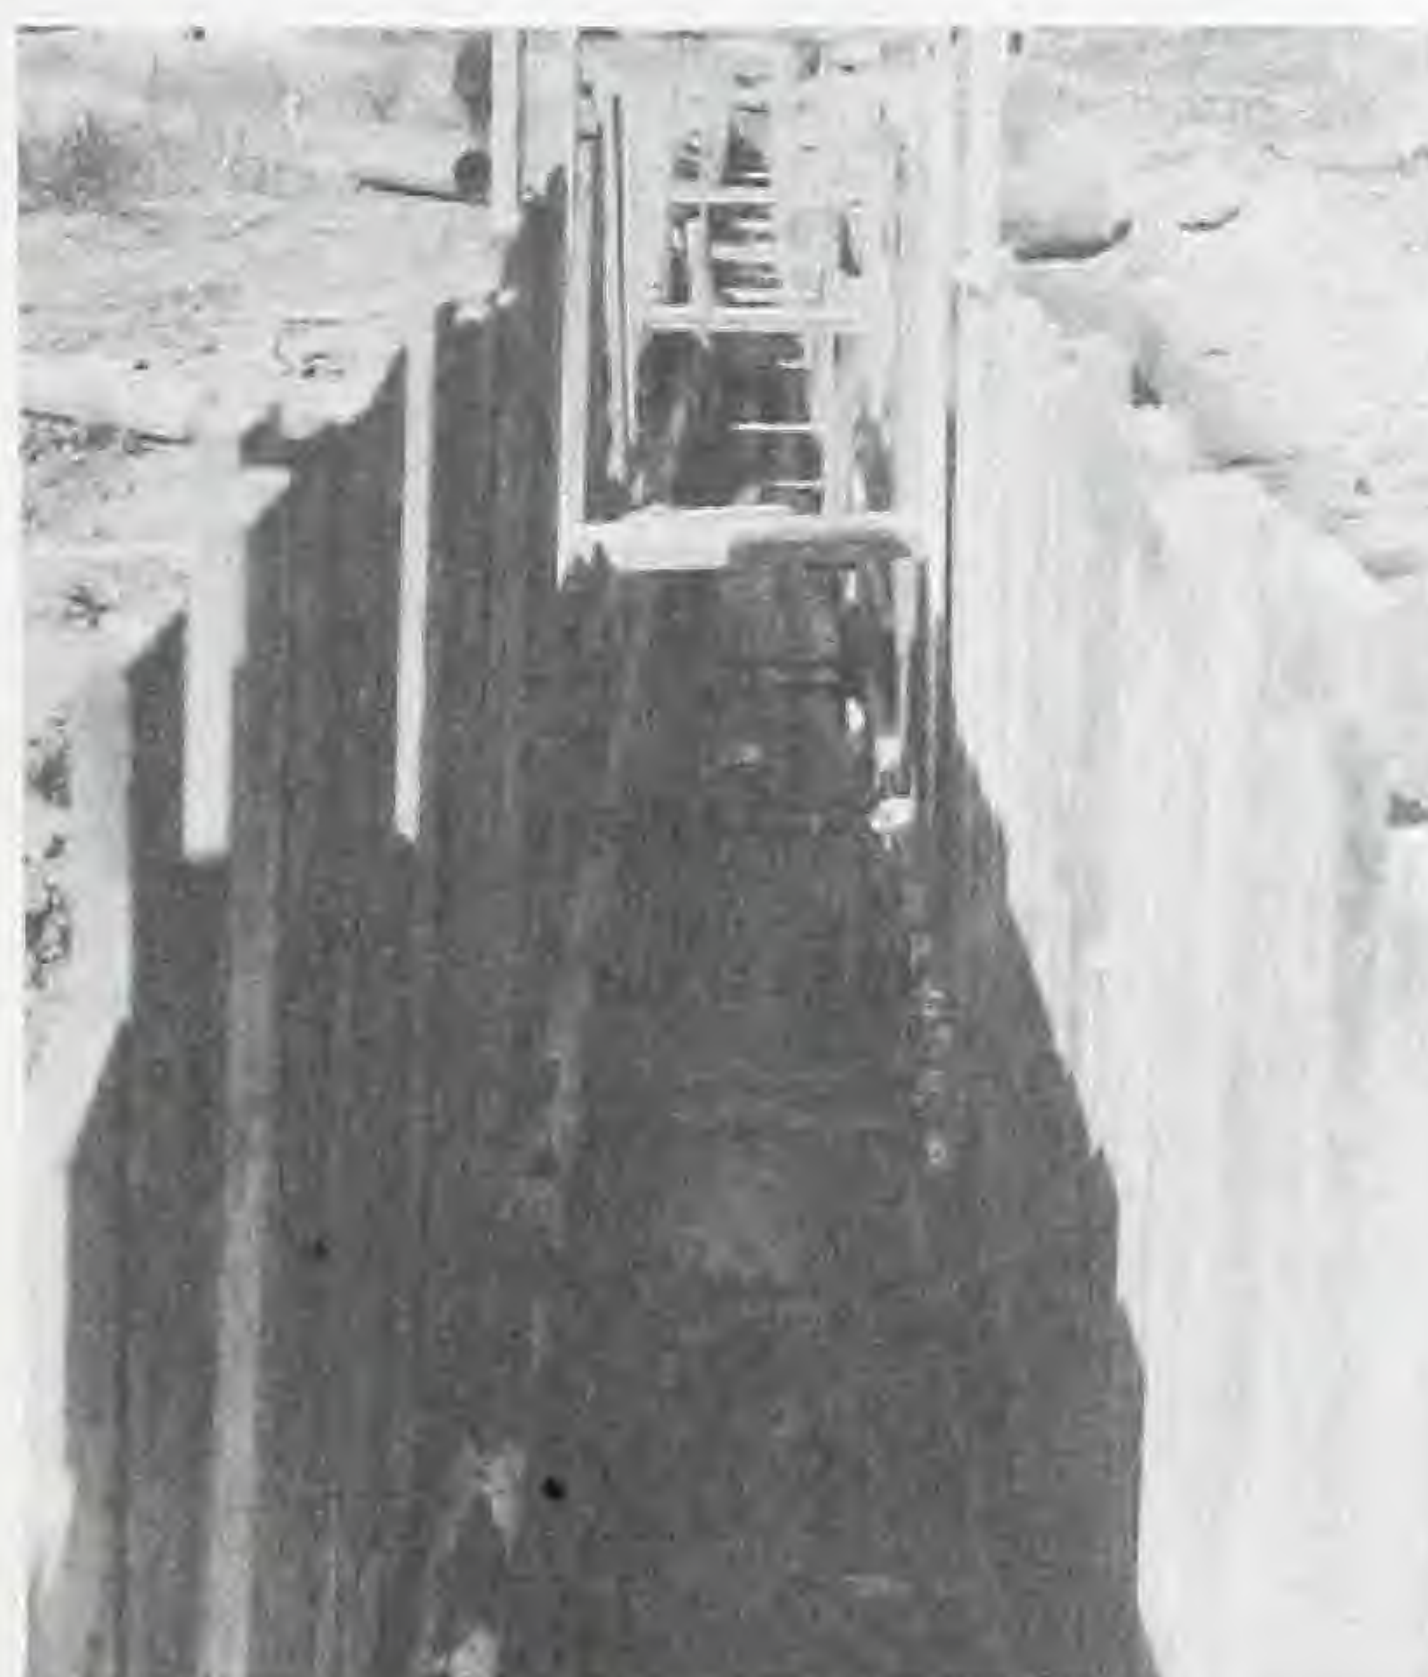
Since the middle 1920's, when the residential village of Mariemont, near Cincinnati, Ohio, was constructed by the Thomas J. Emory Memorial, a central steam distribution system has been in service. Fig. 44 shows one of the steam mains being welded, prior to application of insulation consisting of two layers of asbestos, one of bright tin, and several inches of wood. Tar-paper was placed over the insulated pipe before the trench was back-filled. The insulated main, ready for the backfill, is shown in Fig. 45.

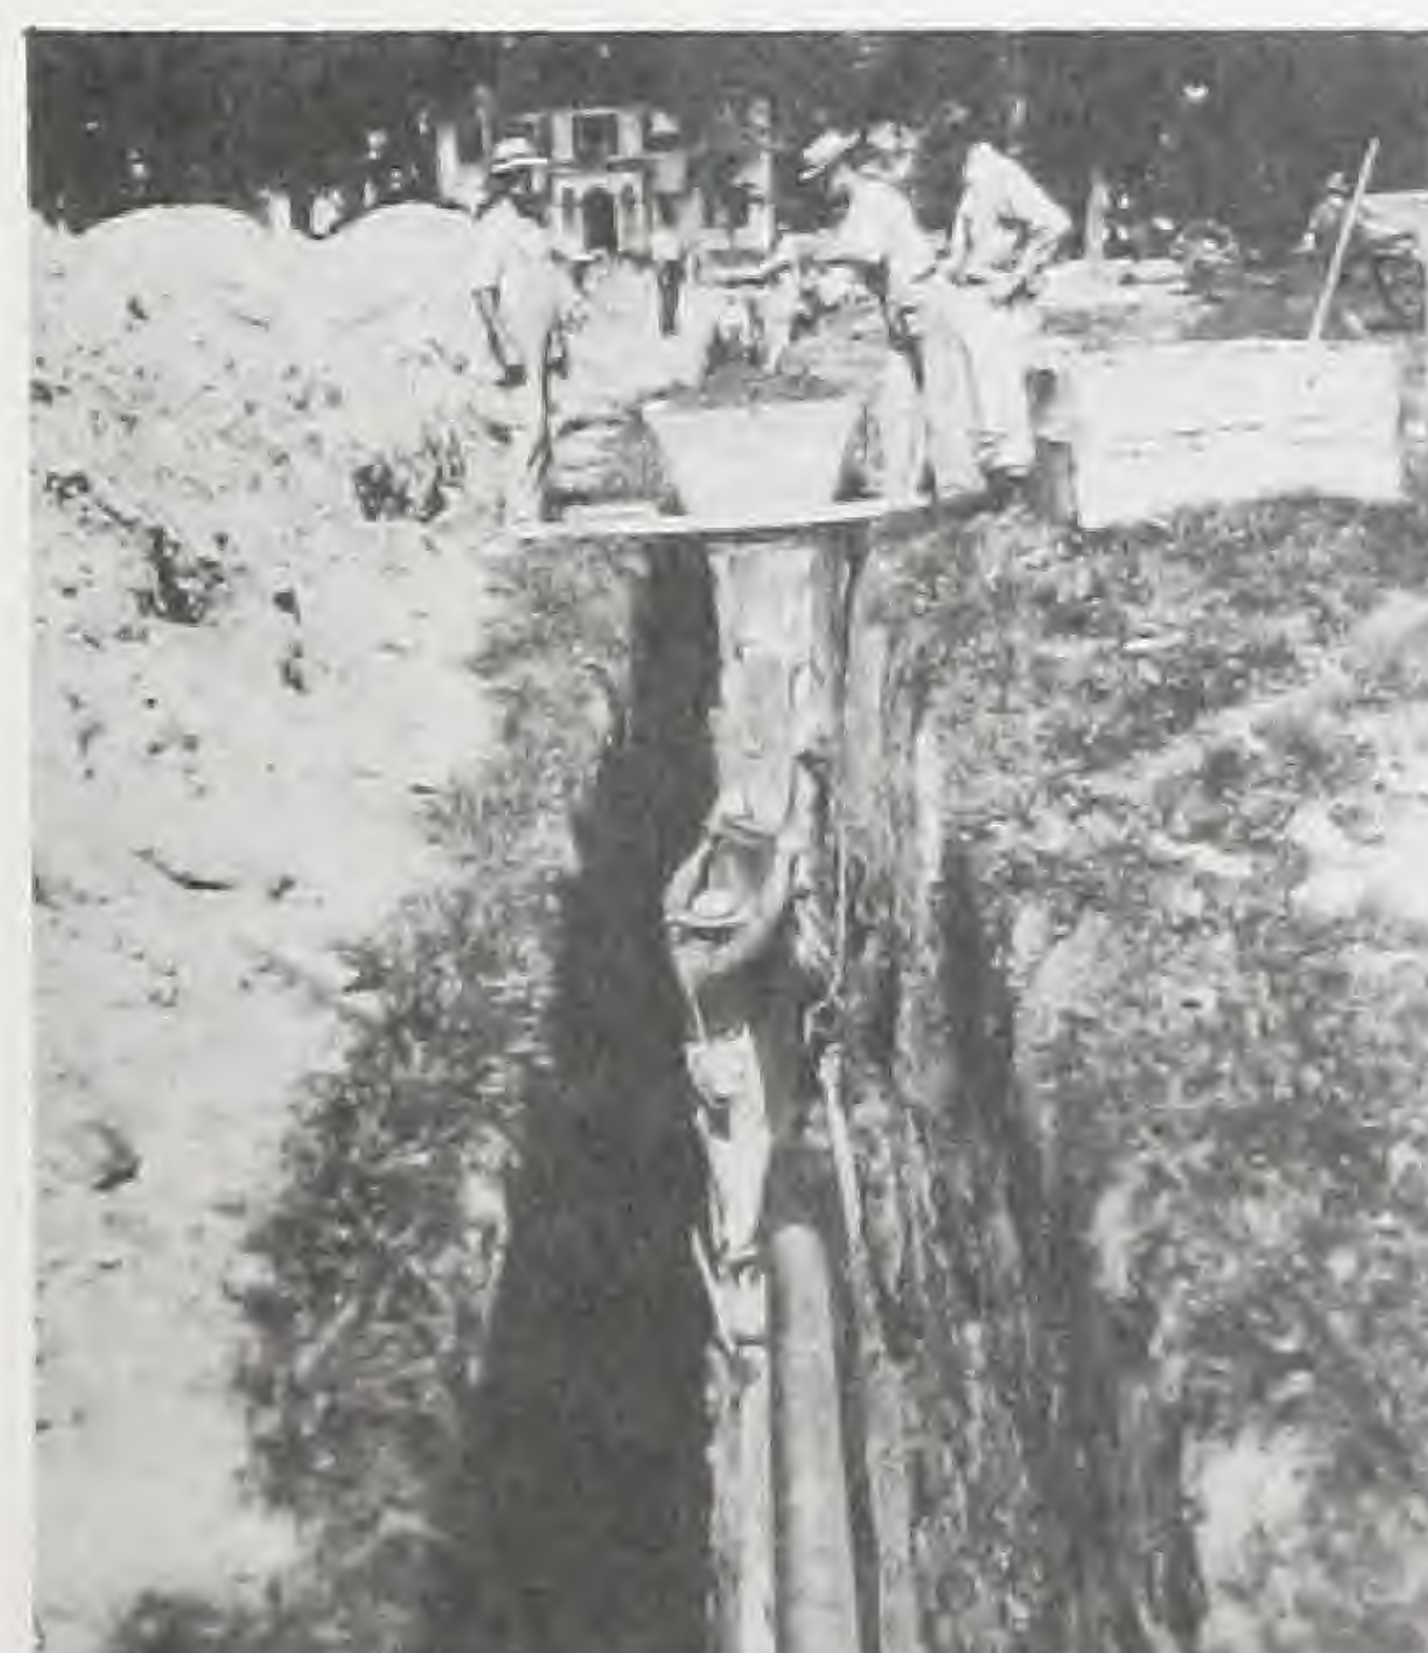
Similar installation methods have been used at Dartmouth College, Hanover, New Hampshire, ever since wrought iron was used in the original central heating system. The photograph marked Fig. 47 was taken in 1897 and shows workmen dumping a mixture of ground cork and sawdust around the pipe as it lay in its tile duct.

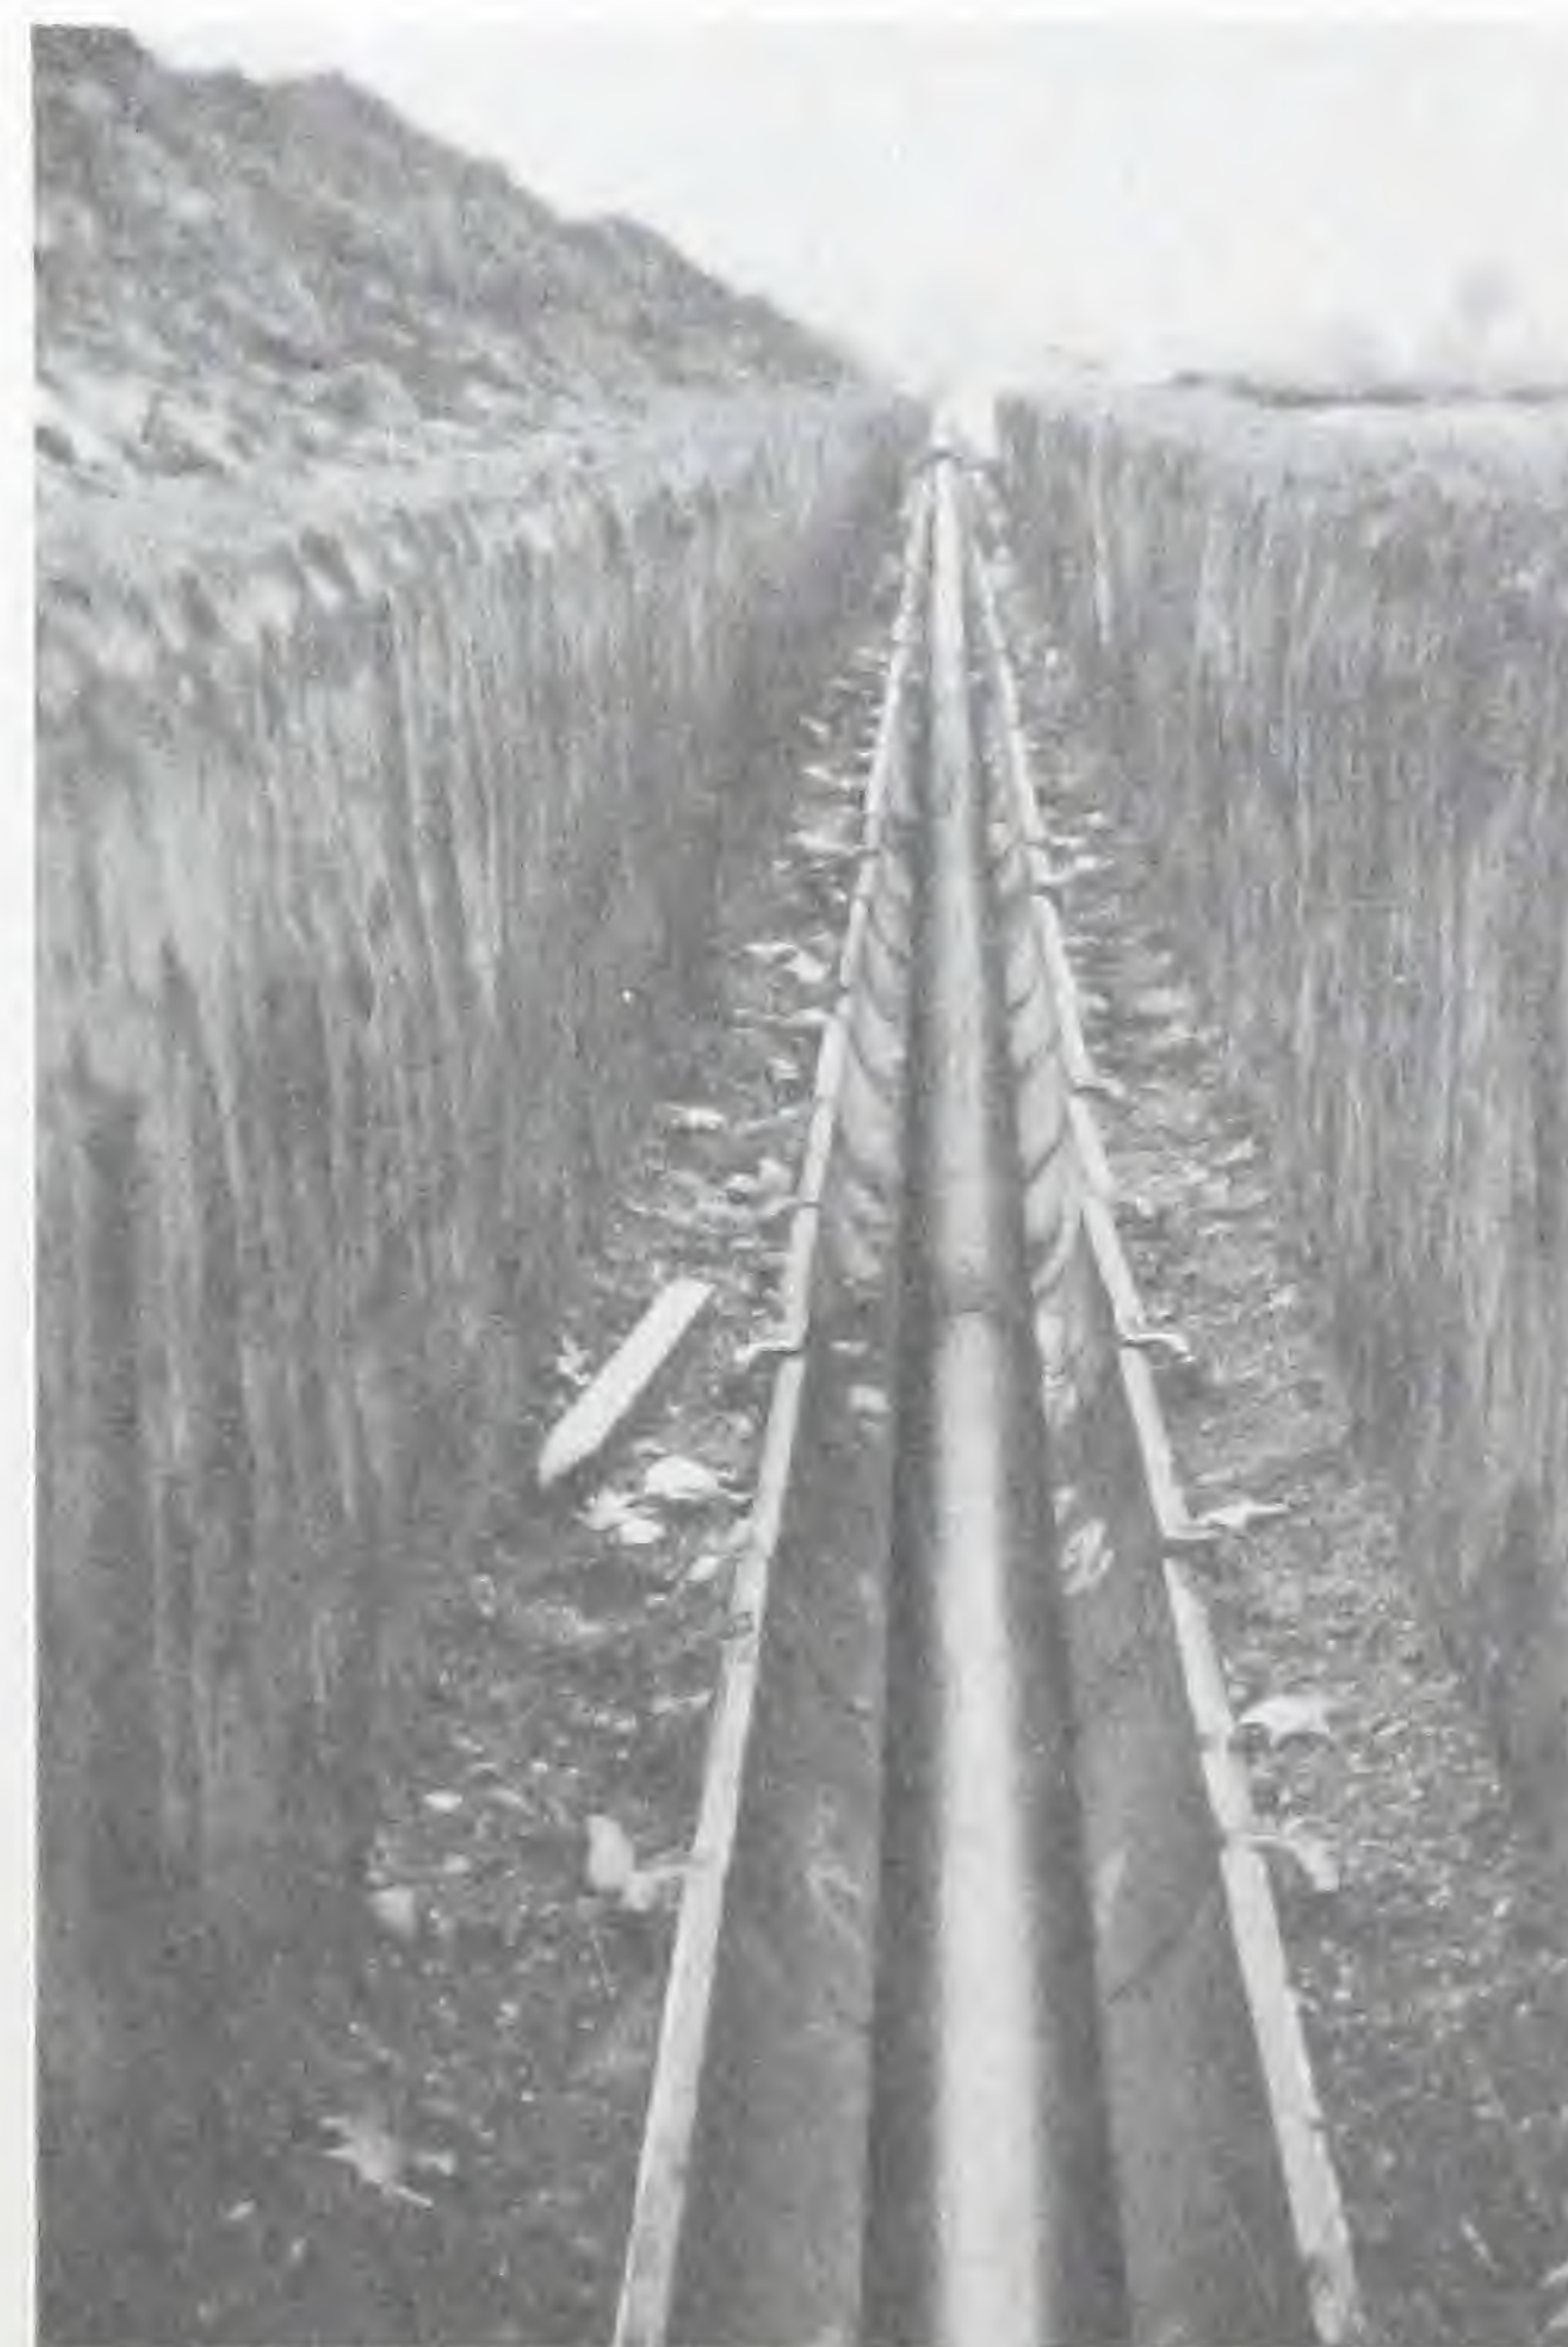
Practically all the original wrought iron pipe is still in use. Fig. 48 shows wrought iron pipe being installed in a recent addition to Dartmouth's steam system, when an asbestos-insulated line was run to the new Physics Building.

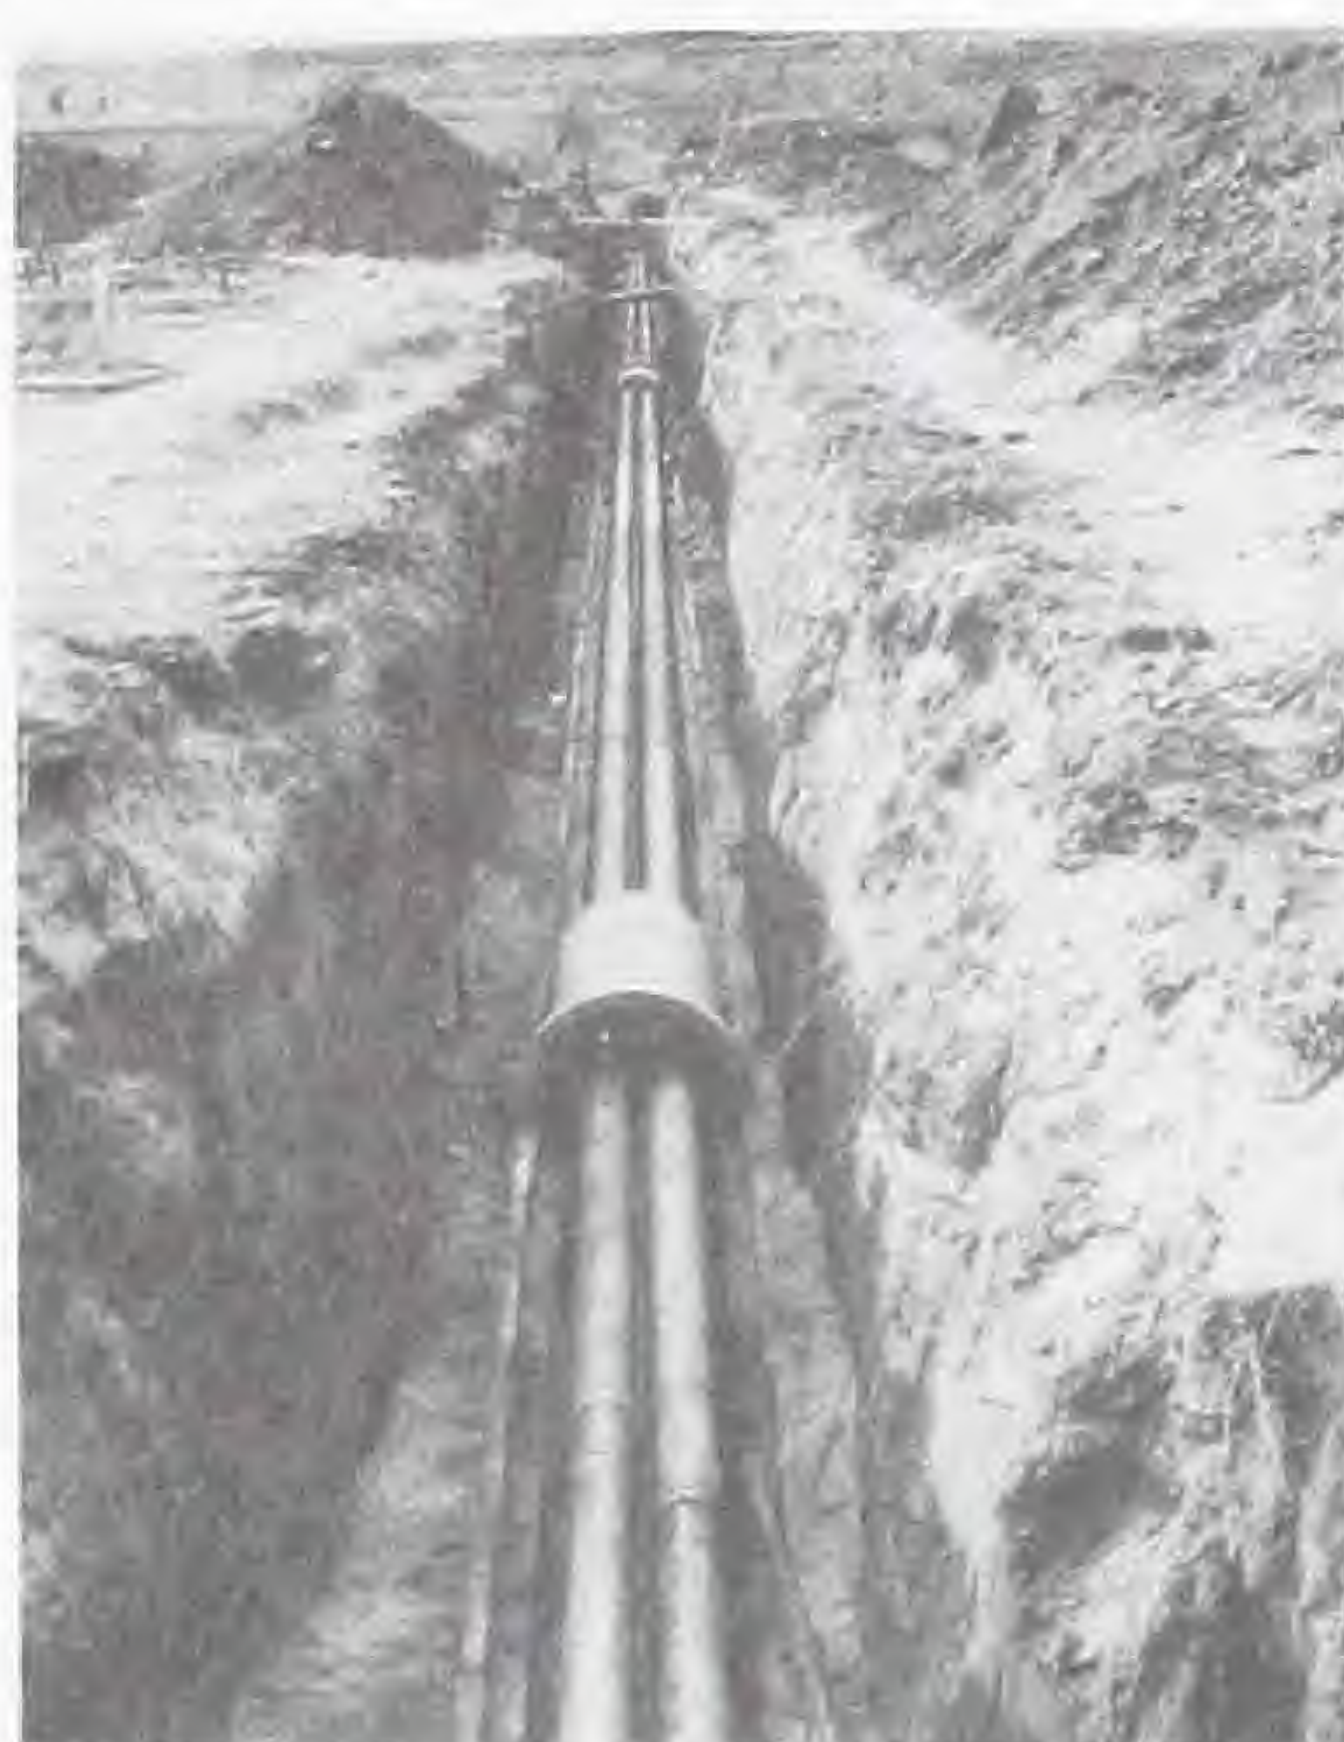
In sewage treatment plants, wrought iron is often used for underground heating lines, and Fig. 49 shows 4" galvanized wrought iron pipe being installed in split tile conduit to carry hot water used for heating sludge digestion tanks at the Springfield, Massachusetts, Sewage Treatment Plant.<sup>13</sup>

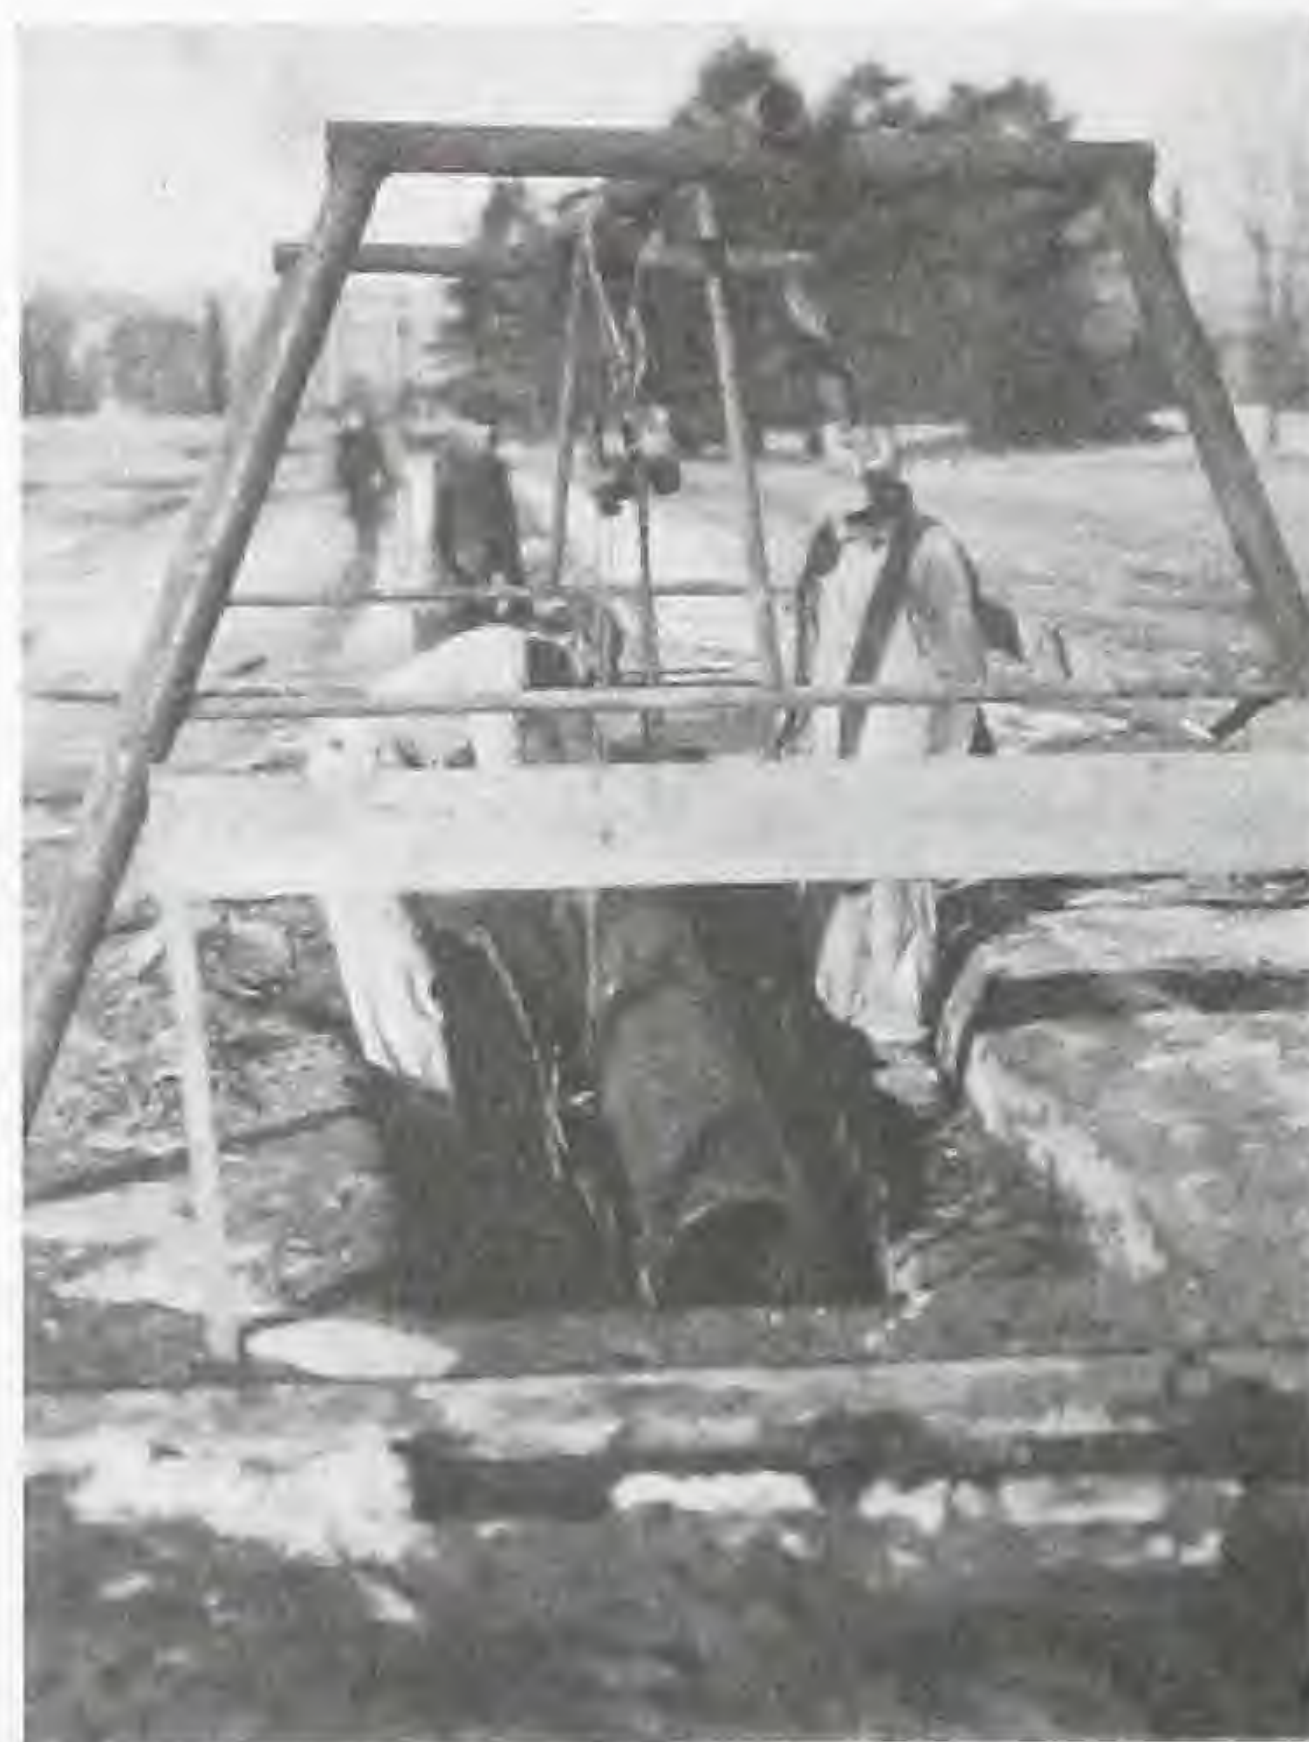
An interesting method for handling 6" and 14" wrought iron pipe was recently used to facilitate installing some low-pressure steam lines at Iowa State College, Ames, Iowa. Fig. 50 shows part of the pipe being placed in the concrete box tunnel. The joints were all welded.

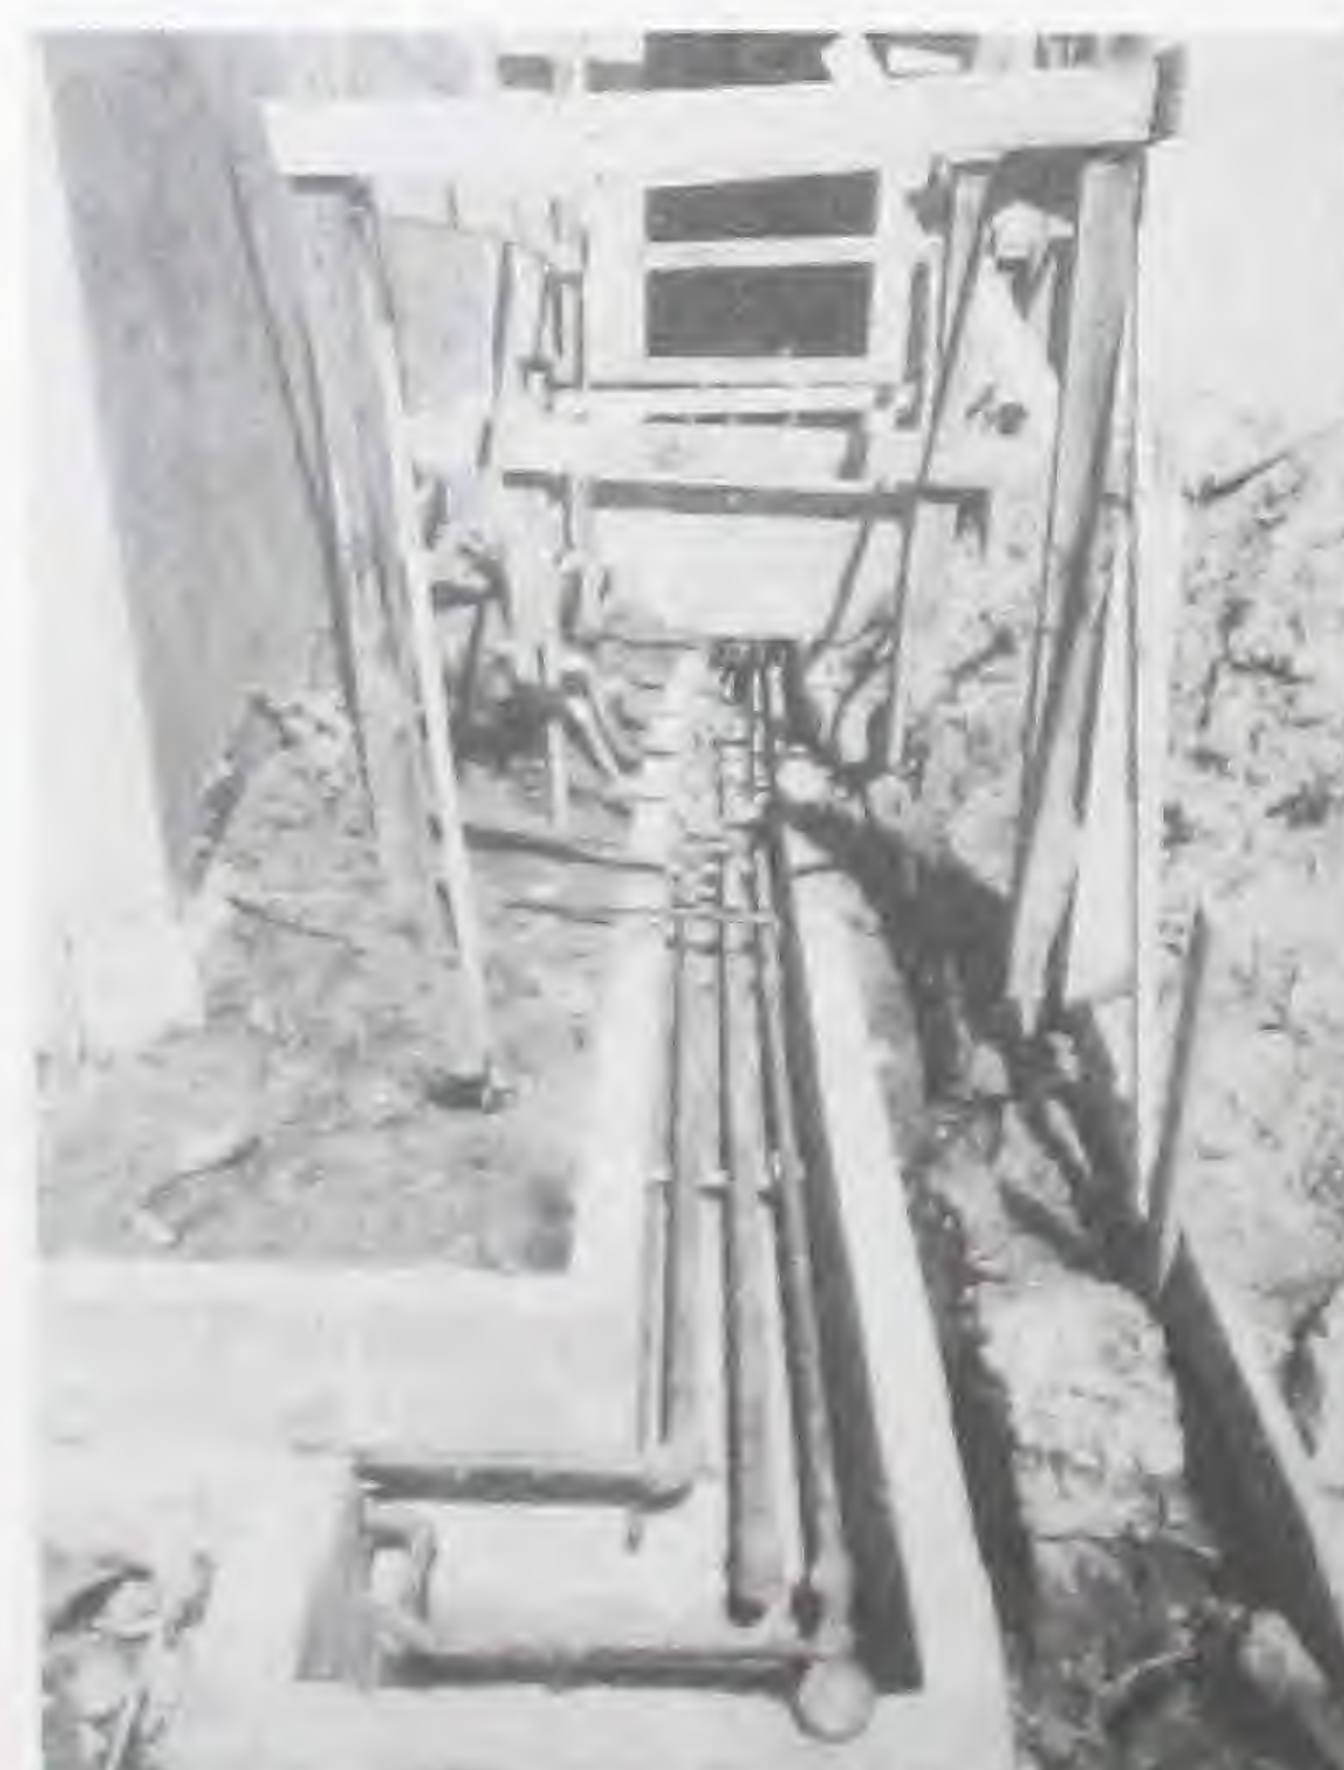
for all tunnel piping. Part of the installation is shown in Fig. 51 shortly before the tunnel was covered.
